SERVICE BULLETIN

Classification: BT00-001	Reference: NTB00-015	Date: February 10, 2000
-----------------------------	-------------------------	----------------------------

1995-1999 MAXIMA TRUNK LID POPS OPEN

APPLIED VEHICLE(S): 1995-1999 Maxima (A32)

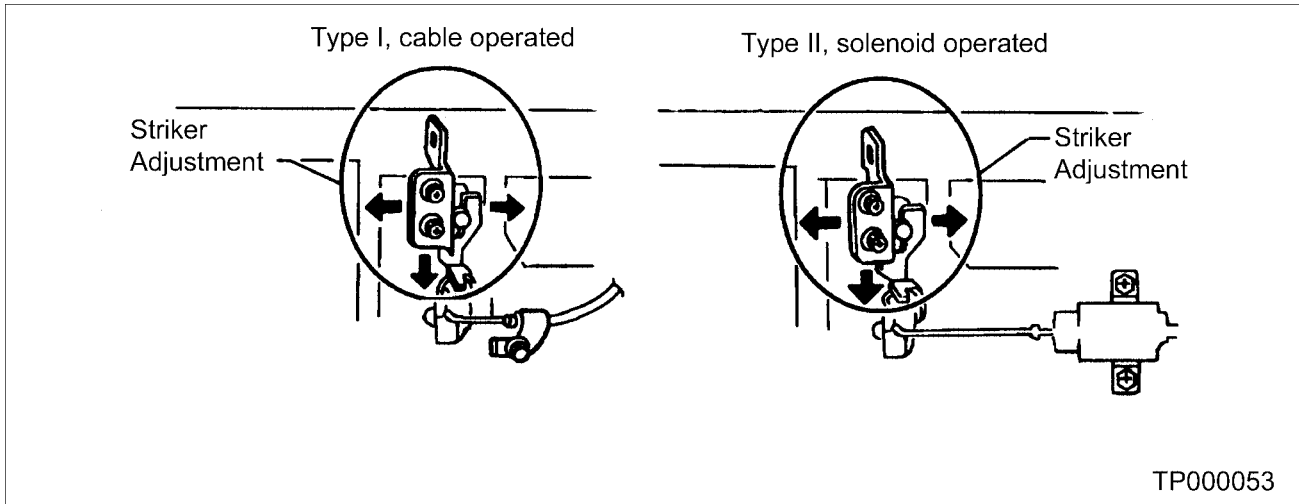
Figure 1

The symptoms of an improperly adjusted trunk lock striker are: The incident occurs without touching the trunk switch on the door. Also, there is no sound from the trunk solenoid/actuator when the incident occurs. Cars equipped with rear spoilers may be more sensitive to this cause. With the trunk lid closed, push down on the trunk lid. If it moves down, the striker needs adjustment. Go to Procedure 1.

2. Loosen the bolts that secure the striker to the body (see Figure 1).

3. Adjust the striker downward to eliminate trunk lid free-play. Temporarily tighten the bolts.
4. Close the trunk lid and verify the free-play is eliminated. Ensure the trunk lid sits flush with the fender edges.
5. Open the trunk lid and torque the 10mm striker bolts to 3.8 ft lb.
6. Check the trunk lid opener cable adjustment (see Figure 2). Adjust as needed.
