# SERVICE BULLETIN

Classification: BT00-001	Reference: NTB00-015	Date: February 10, 2000
-----------------------------	-------------------------	----------------------------

## 1995-1999 MAXIMA TRUNK LID POPS OPEN

**APPLIED VEHICLE(S):** 1995-1999 Maxima (A32)

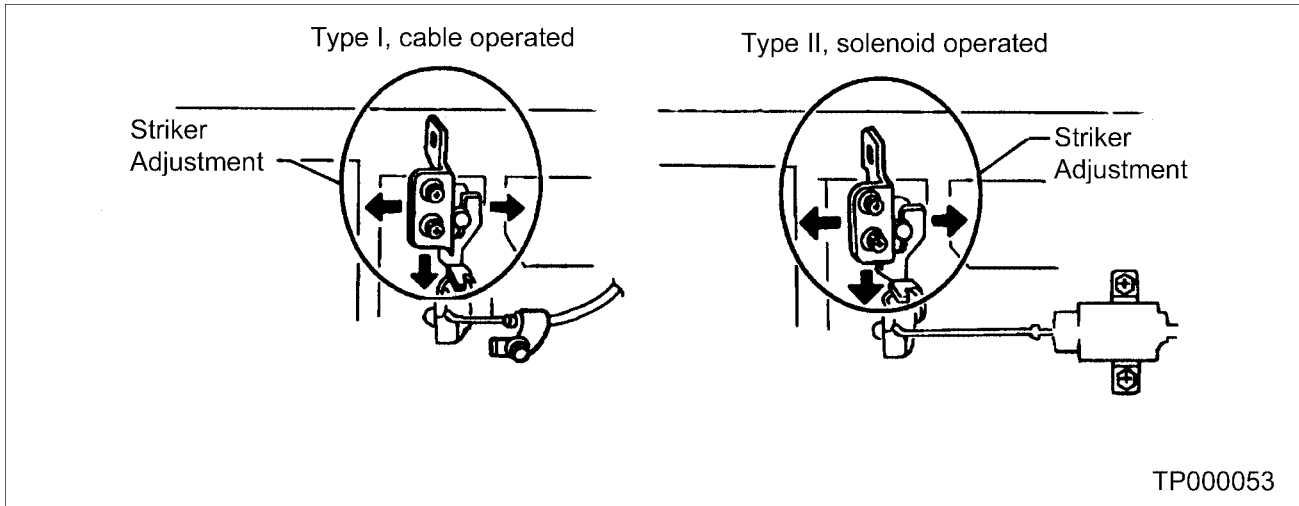
Figure 1

The symptoms of an improperly adjusted trunk lock striker are: The incident occurs without touching the trunk switch on the door. Also, there is no sound from the trunk solenoid/actuator when the incident occurs. Cars equipped with rear spoilers may be more sensitive to this cause. With the trunk lid closed, push down on the trunk lid. If it moves down, the striker needs adjustment. Go to Procedure 1.

2. Loosen the bolts that secure the striker to the body (see Figure 1).

3. Adjust the striker downward to eliminate trunk lid free-play. Temporarily tighten the bolts.
4. Close the trunk lid and verify the free-play is eliminated. Ensure the trunk lid sits flush with the fender edges.
5. Open the trunk lid and torque the 10mm striker bolts to 3.8 ft lb.
6. Check the trunk lid opener cable adjustment (see Figure 2). Adjust as needed.
