SERVICE BULLETIN

Classification: EC00-024a	Reference: NTB00-070a	Date: March 15, 2001
------------------------------	--------------------------	-------------------------

2000-2001 MAXIMA MIL "ON" WITH DTC P0420 STORED – THREE WAY CATALYST FUNCTION

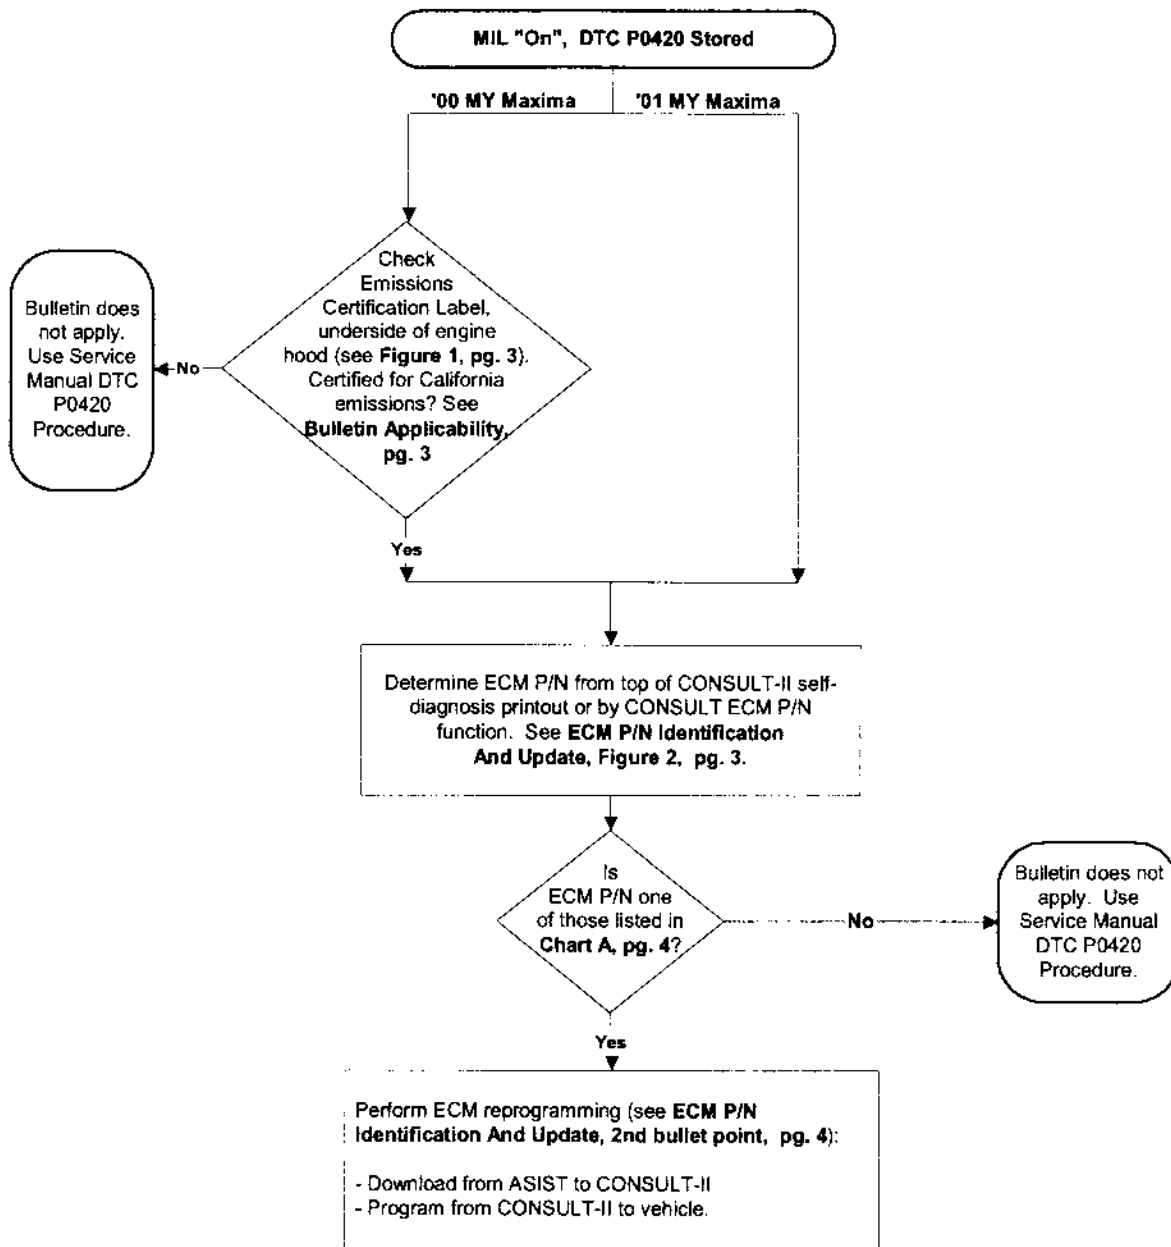
Use the diagnosis/repair flow chart on page 2 and the appropriate Service Procedure steps provided in this bulletin to diagnose and repair this incident, if it should occur, regardless of whether or not the vehicle was previously repaired in accordance with the earlier bulletin.

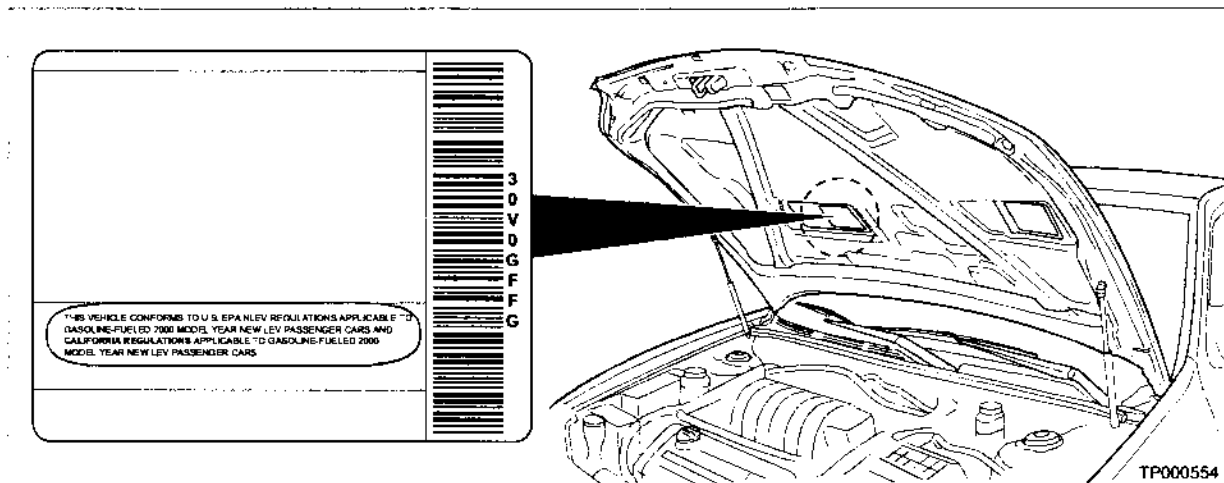
Figure 1

1. For **2000 Maxima vehicles**, check the Emissions Certification Label on the underside of the engine hood (see Figure 1). Is the certificate for California emissions?
 - If the certificate is **not** for California emissions, this bulletin does not apply. Use the Service Manual DTC P0420 Procedures to further diagnose and repair.
 - If the certificate is for California emissions, proceed to **ECM Part Number Identification and Update**.

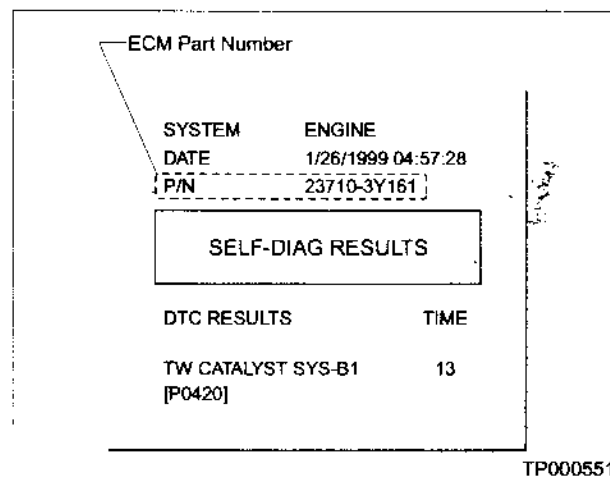
Figure 2

1. Determine the vehicle's ECM Part Number. The ECM P/N is found on top of the CONSULT-II self-diagnosis printout (see Figure 2), or by CONSULT ECM P/N Selection.
