SERVICE BULLETIN

Classification: EL01-001	Reference: NTB01-009	Date: February 9, 2001
-----------------------------	-------------------------	---------------------------

2001 MAXIMA ALARM SOUNDS AFTER 30 MINUTES AND/OR TRUNK LAMP INOPERATIVE

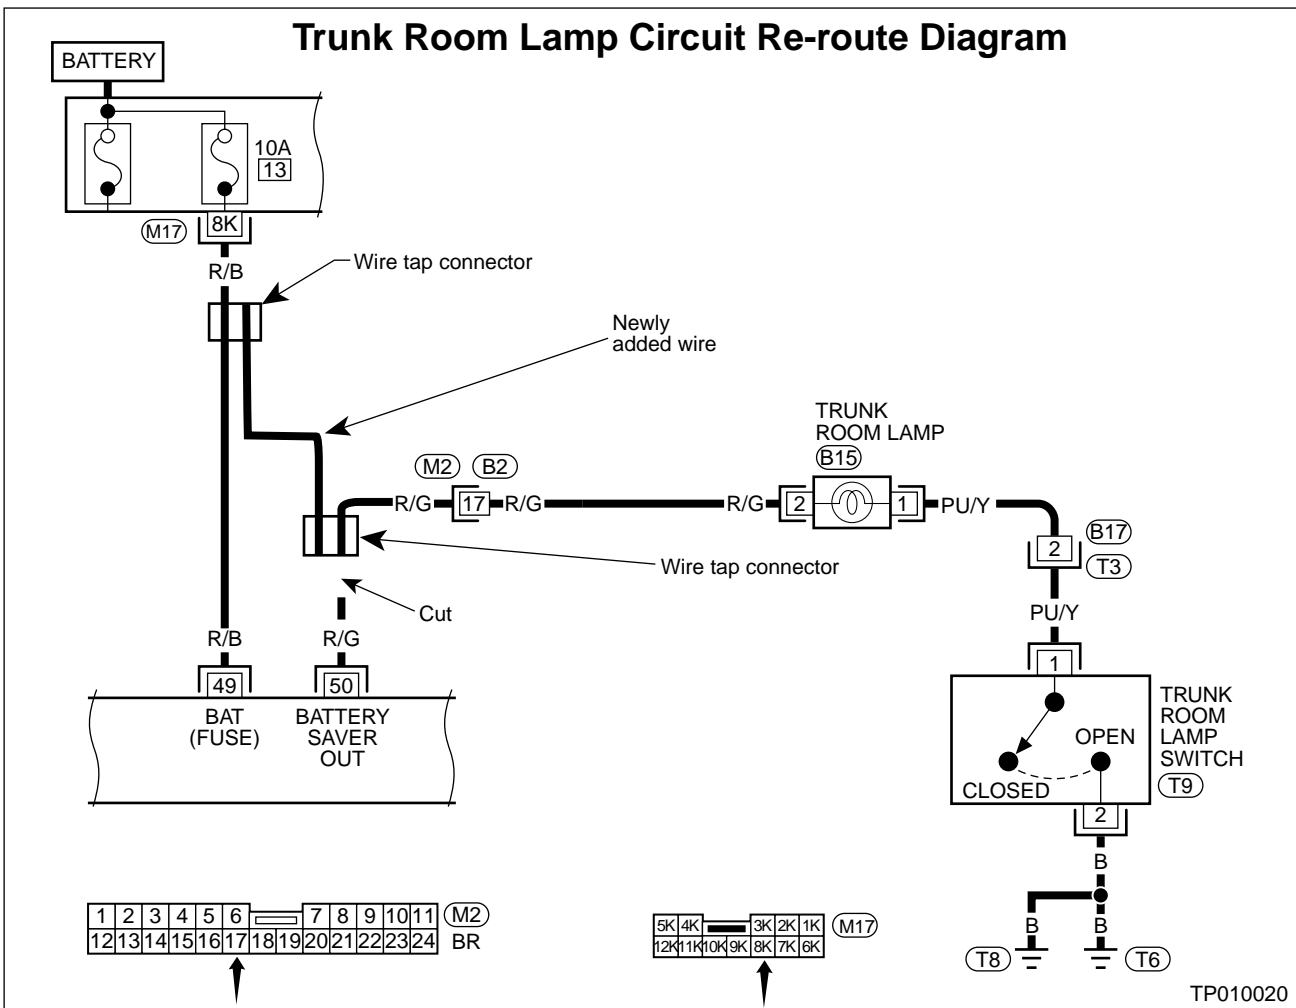
the cause may be the trunk room lamp circuit connection to the battery saver feature of the Smart Entrance Control Unit (SECU).

If either of the conditions described exist, perform the **Trunk Room Lamp Circuit Re-routing Procedure** in this bulletin to connect the trunk room lamp circuit directly to a battery circuit. A Sub-harness kit consisting of two wire tap connectors and a sub-harness wire is available to complete the re-route procedure.

NOTE: See Figure 7 for an overview of this repair:
