# SERVICE BULLETIN

Classification: EC01-009A	Reference: NTB01-018A	Date: October 17, 2001
------------------------------	--------------------------	---------------------------

## 2000-2001 MAXIMA WITH M/T; ON/OFF THROTTLE SENSITIVITY

**APPLIED VEHICLES:** 2000-2001 Maxima (A33) with Manual Transmission (M/T) Only

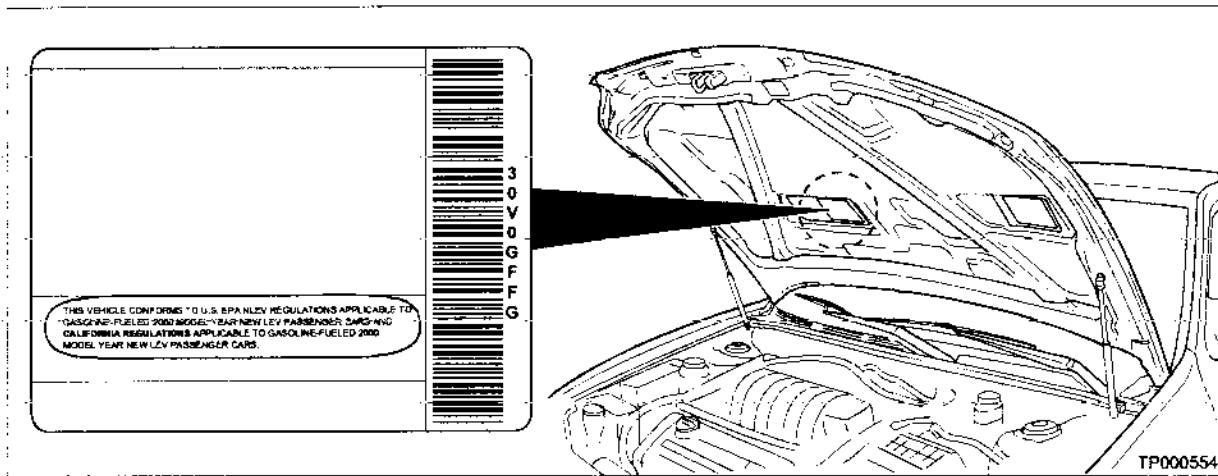
Figure 1

- For **2000 Maxima vehicles**, you need to determine if the vehicle is certified for California or Federal emissions. Check the Emissions Certification Label on the underside of the engine hood to verify if the certificate is for California emissions (see Figure 1). If there is no mention of California on the label, the vehicle is certified for Federal emissions.
