SERVICE BULLETIN

Classification: EL01-007	Reference: NTB01-021	Date: March 23, 2001
-----------------------------	-------------------------	-------------------------

2000-2001 MAXIMA; SUNROOF GLASS OPERATES BY ITSELF

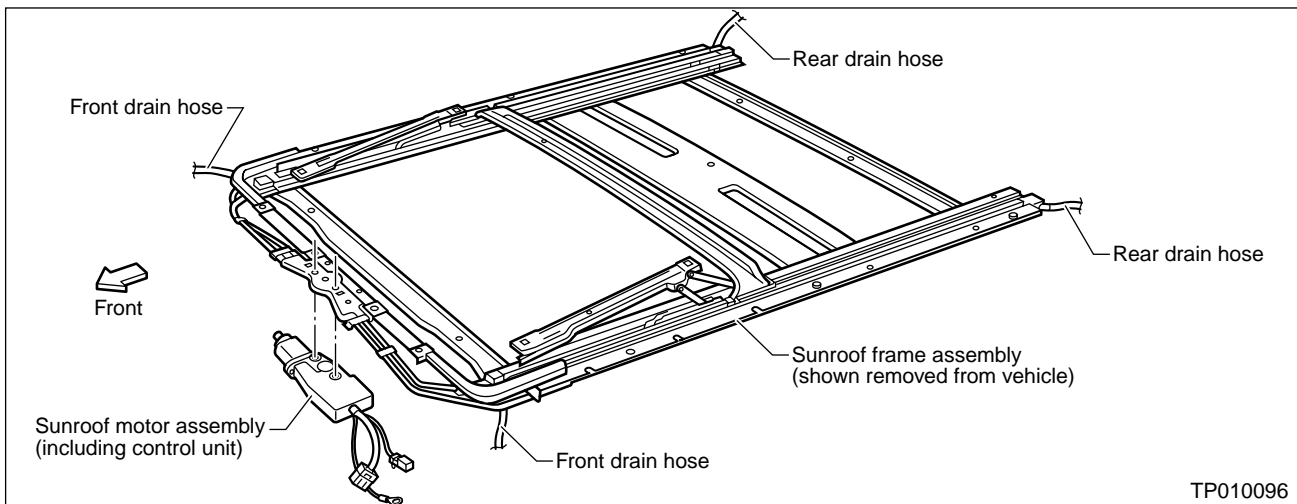
If the sunroof of an Applied Vehicle operates without the switch being pushed, it may be because of water contamination of the sunroof motor assembly. This could occur if the sunroof frame assembly is not draining correctly. A replacement sunroof frame assembly is available which allows for better draining if this incident should occur.

- A. Pour a small amount (less than 1 cup) of water into the front of the sunroof frame assembly, at the location of the front drain hoses (see Figure 1 on page 1 of this bulletin).
 - B. Watch for water draining into the wheelhouse areas at all four corners of the vehicle.
 - If water can be seen draining from the hoses, proceed to step 5.
 - If not, clear the hoses (refer to the BT section of the appropriate Service Manual) and then proceed to step 5.
5. Replace the sunroof motor assembly and the sunroof frame assembly with the ones from the Parts Information section of this bulletin. Follow the instructions in the BT section of the appropriate Service Manual.

3. Remove the plastic cover plate from the sunroof motor and inspect the circuit board:
 - If the circuit board is wet or is corroded, water is not draining correctly from the sunroof tray. Replacement of the sunroof motor AND the sunroof tray with the one listed in the Parts Information section of this bulletin is needed.
IMPORTANT: First, check the sunroof drains. See step 4 below.
 - If the circuit board is not wet or corroded, check for other possible causes of the incident. Refer to the EL section of the appropriate Service Manual for diagnosis of the sunroof switch and/or its circuits.
4. With the vehicle parked on a level surface, check the sunroof drains for blockage as follows:
