SERVICE BULLETIN

Classification: BT01-017	Reference: NTB01-029	Date: May 2, 2001
-----------------------------	-------------------------	----------------------

2000-2001 MAXIMA WIND NOISE REAR GLASS RUN RUBBER

APPLIED VEHICLES: 2000-2001 Maxima (A33)

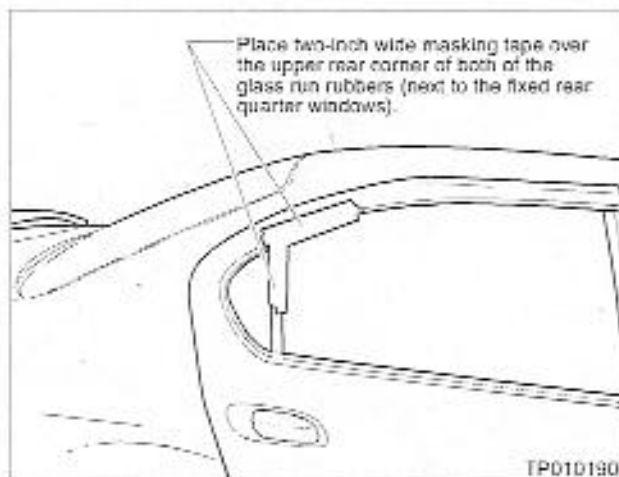
There may be too much clearance between the rear door glass run rubber and top corner of the window partition sash (next to the fixed quarter window) causing a wind leak. See Figure 1 for location.

1. Road test the vehicle under the conditions described above to confirm the noise is present.
2. If the wind noise is heard during the road test, place two-inch wide masking tape over the upper rear corner of both of the glass run rubbers - next to the fixed rear quarter windows. See Figure 1.
