SERVICE BULLETIN

Classification: BT01-043	Reference: NTB01-071	Date: October 17, 2001
-----------------------------	-------------------------	---------------------------

2000-2001 MAXIMA; DRIVER'S SEAT MOVES SIDE-TO-SIDE

APPLIED VEHICLE: 2000-2001 Maxima (A33) with Manual Adjustable Seats Only

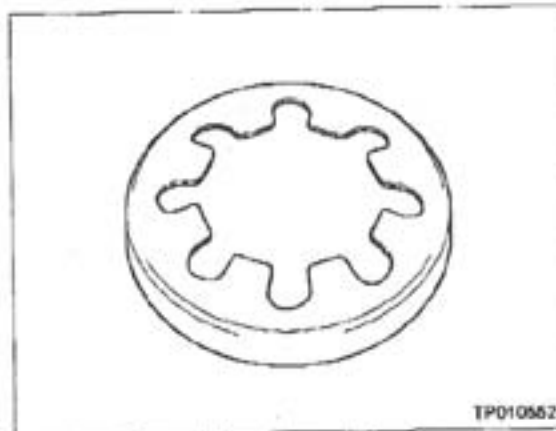
Figure 1

If there is a slight side-to-side movement of the driver's seat while making a left or right turn, it may be repairable by installing a push nut (see Figure 1) on the RH end of the front lifter shaft.

Use the Service Procedure in this bulletin to install the push nut if the vehicle exhibits the described symptom.

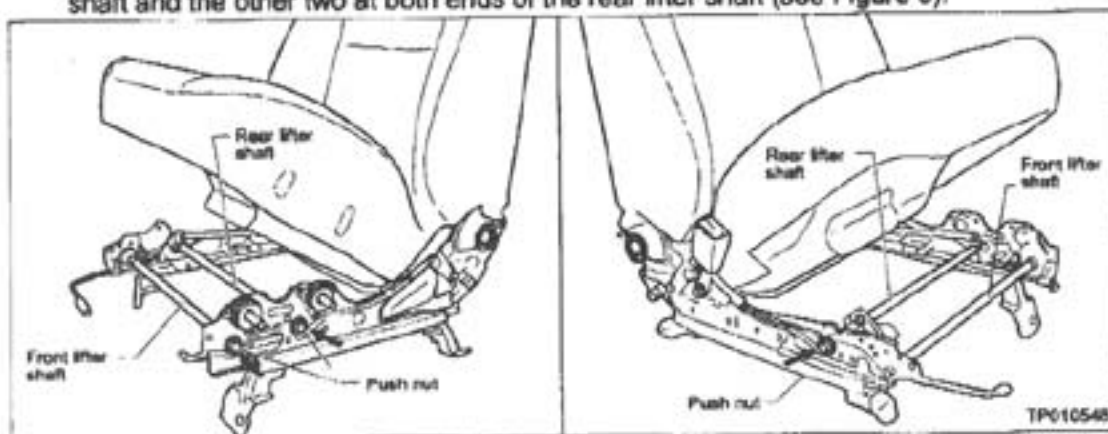
Figure 6

8. Inspect the three push nuts. One push nut is located at the LH end of the front lifter shaft and the other two at both ends of the rear lifter shaft (see Figure 6).

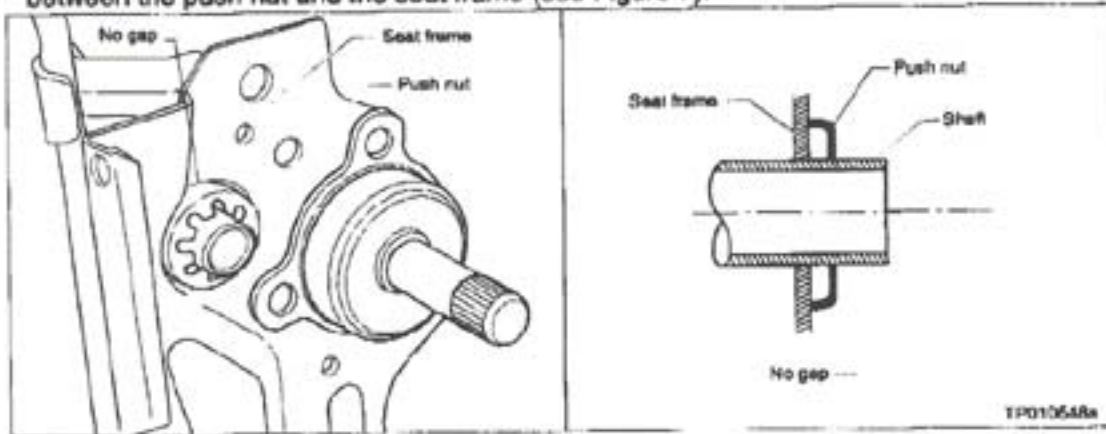
Ensure the push nuts are pressed tight against the seat frame; no gap should exist between the push nut and the seat frame (see Figure 7).
