SERVICE BULLETIN

Classification:	Reference:	Date:
BT01-042	NTB02-005	January 7, 2002

2001-2002 MAXIMA HOOD VIBRATION

APPLIED VEHICLES: 2001-2002 Maxima (A33)

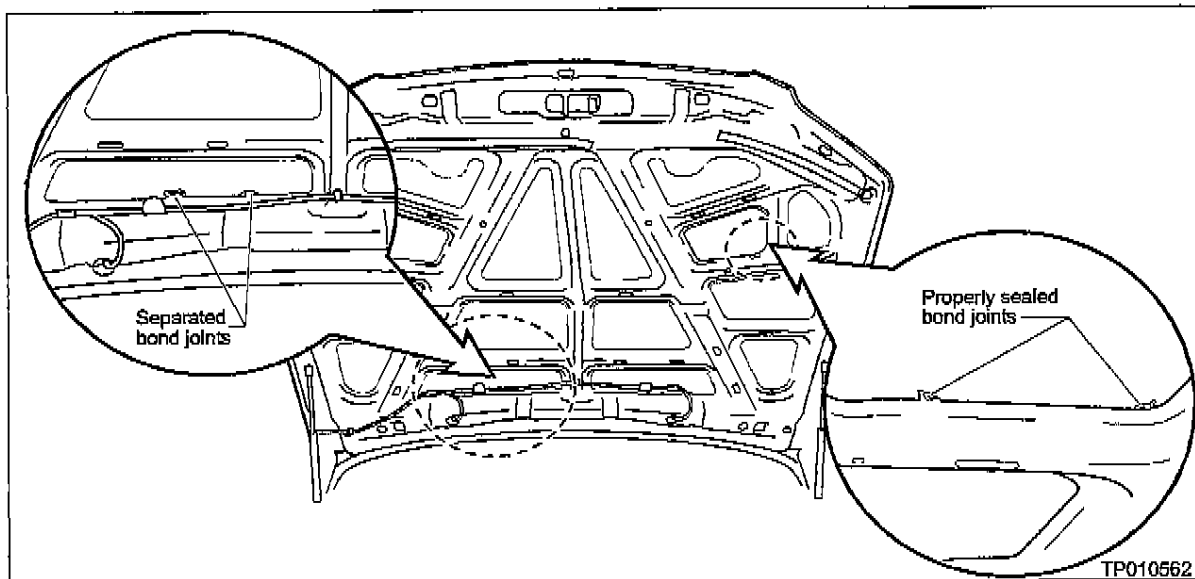
1. Open the hood and remove the hood insulation pad.
2. Visually examine all the adhesive/mastic bond joints between the hood sheet metal and hood inner structure (see Figure 1 for examples of separated bond joints and properly sealed bond joints).

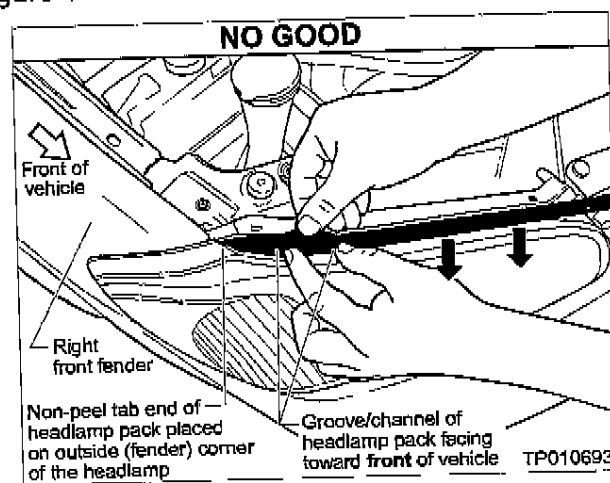
Figure 7 (below) shows improper installation of the Right-hand Headlamp Pack. The groove/channel is facing **forward**, N/G.
