SERVICE BULLETIN

Classification: EL01-025	Reference: NTB02-007	Date: January 8, 2002
-----------------------------	-------------------------	--------------------------

2000-2002 MAXIMA; ALL DOORS MAY INTERMITTENTLY LOCK BY THEMSELVES

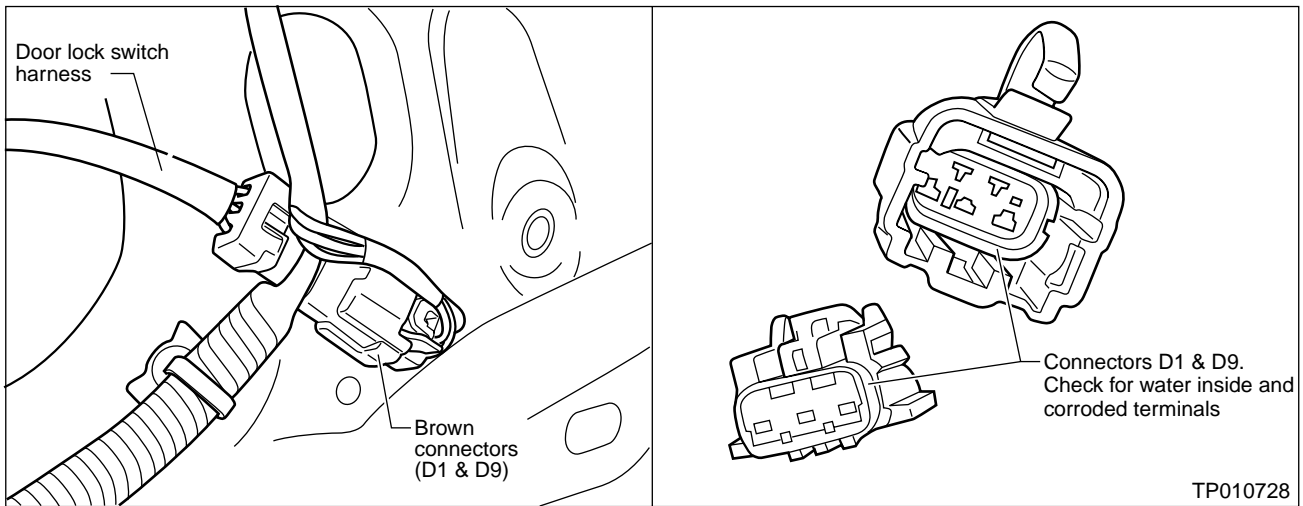
Figure 1

1. Remove the LH front door finisher. Refer to the BT section of the ESM.
2. Inspect the brown connector for the door lock switch harness (D1,D9) for any evidence of moisture (water condensation, droplets) and/or corrosion (see Figure 1).

3. If moisture or/and corrosion is found,
 - Proceed to step 6 and replace the door lock switch assembly and the LH door harness.
4. If moisture or/and corrosion is not found, this bulletin does not cover the incident.
 - Refer to the ESM to further diagnose and repair the incident.
5. Prepare the LH door harness connector (D1) to the (M4) SMJ as follows:
