SERVICE BULLETIN

Classification: EL02-009	Reference: NTB02-039	Date: April 3, 2002
-----------------------------	-------------------------	------------------------

2001-2002 NISSAN TACHOMETER NEEDLE ON WRONG SIDE OF STOP PIN

APPLIED VEHICLES: 2001-2002 - All Nissan Vehicles, **Except Quest**

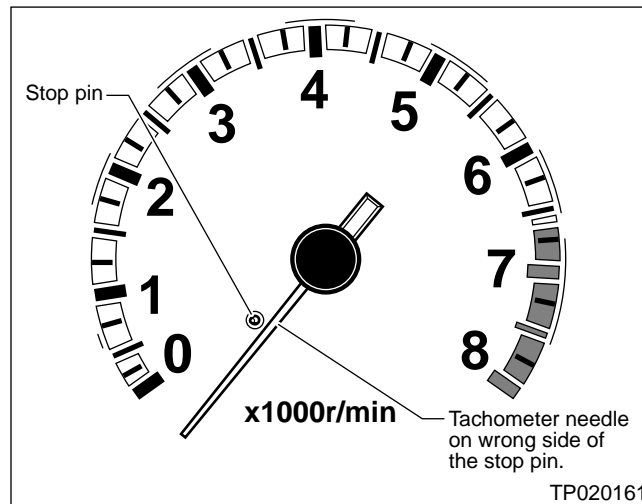
Figure 1

- The Tachometer Needle is on the wrong side of the stop pin (see Figure 1),

DO NOT replace the Tachometer. The incident can generally only occur if the storage fuse has been removed, and the ignition key is turned OFF while the engine is operating over 4500 RPM.

Therefore, this situation is most likely to occur after the vehicle leaves the factory, but before the dealer performs the Pre-Delivery Inspection (PDI).

1. With the storage fuse installed, put the vehicle in "PARK" or "NEUTRAL."
2. **Carefully** raise the engine RPM briefly to approximately 6000 RPM, until the tachometer needle resets to its normal range of operation. Release the throttle as soon as the tachometer resets.

CAUTION: DO NOT run the engine at this speed for more than 2-3 seconds.
