SERVICE BULLETIN

Classification: BT95-013	Reference: NTB95-012	Date: January 25, 1995
-----------------------------	-------------------------	---------------------------

1995 MAXIMA WIND NOISE AROUND FRONT DOOR

APPLIED VEHICLE(S): 1995 Maxima (A32)

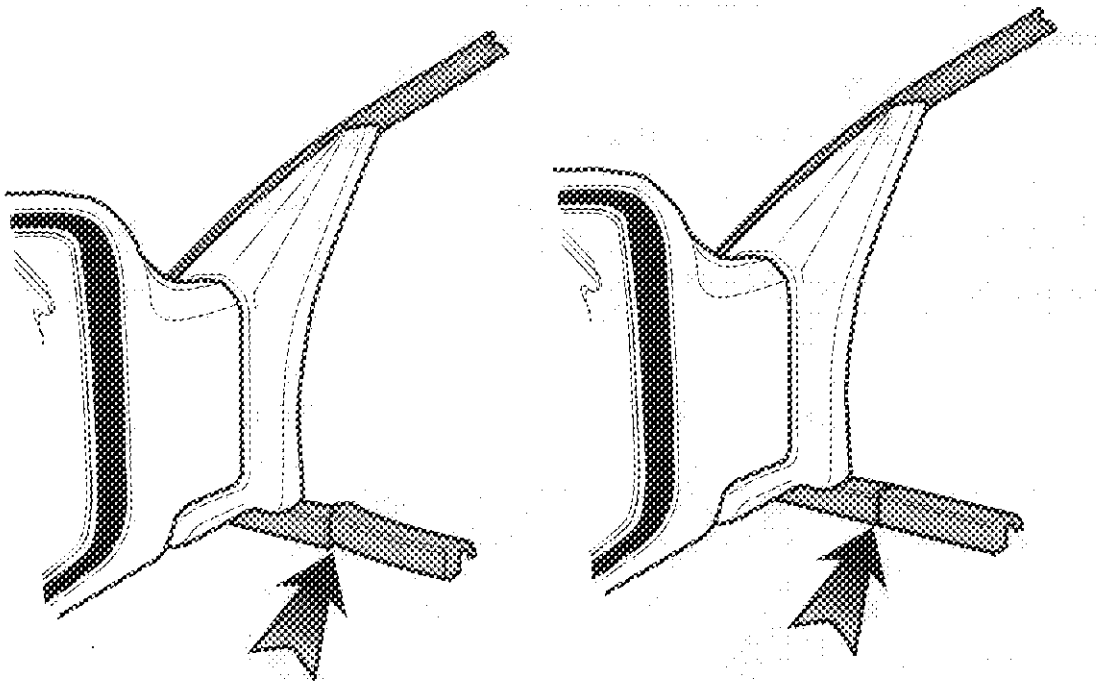
1. First drive the vehicle with the customer to confirm the actual level and location of the wind noise complaint. Isolate the location of any abnormal noise (i.e. mirror, A-pillar, top of door glass, etc.)
2. Inspect the following areas:
 - A. Inspect the leading edge of the window waist molding. The front seam of this molding must be completely flush where it contacts the mirror base molding. Any gap or misalignment of this seam may result in turbulence or wind noise.

POORLY ALIGNED AT JOINT

MOLDINGS MUST BE EVEN AT JOINT

If a gap or poor alignment exists, realign the window waist molding to the mirror base molding. Page BF-22 describes installation of this molding in illustration #13.

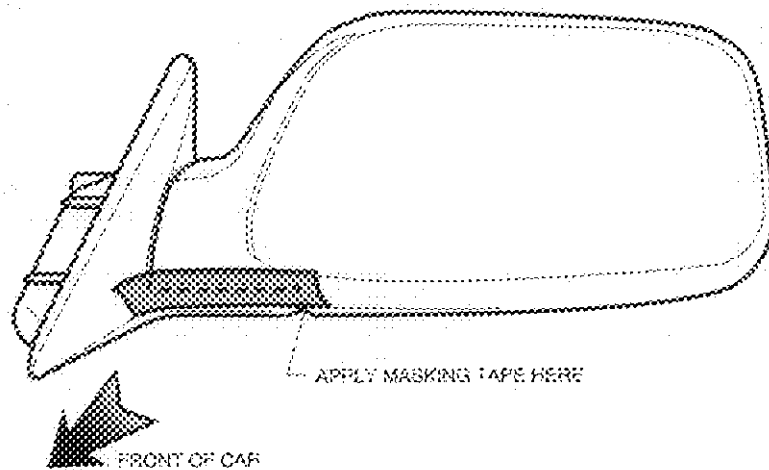
- B. Inspect the horizontal opening at the base of the mirror. Taping off the horizontal opening will help isolate this possible wind noise location. See the illustration below for additional details.

Test drive the vehicle and attempt to duplicate the customers complaint. If the noise level is reduced, installation of a new foam strip between the mirror base and mirror head is required. See illustration below.

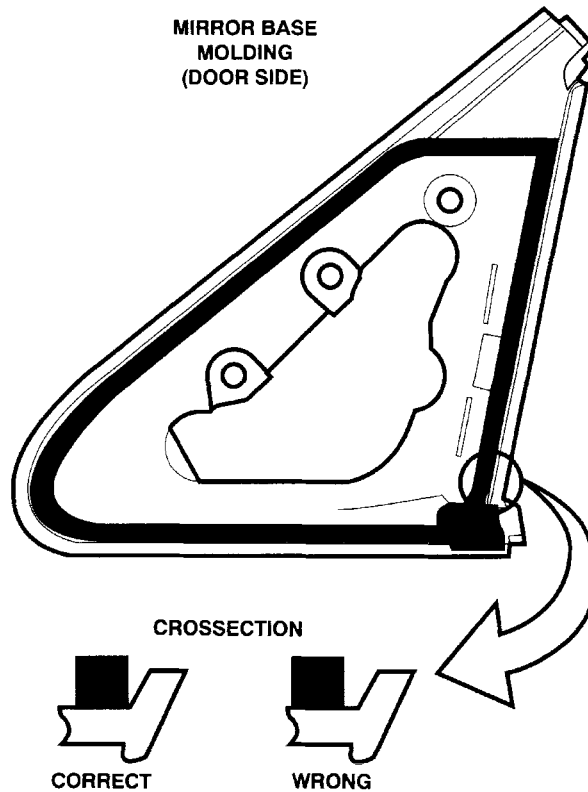
- C. Inspect the mirror base molding for correct installation and seal. The foam tape used to seal the mirror base to the door panel may not be correctly located. See sketch below. Replace the mirror base molding and reinstall the mirror to correct this condition.

Remove any incorrectly positioned foam tape. Install new 1/4" wide by 1/8" thick single-sided adhesive foam tape as needed (cut from 3M SCOTCH FOAM #4508 or equivalent). Position new tape to ensure a complete seal between mirror base molding and door panel. New tape should overlap glass run rubber adjacent to rear edge of mirror base molding.
