SERVICE BULLETIN

Classification: FE95-001	Reference: NTB95-025	Date: February 22, 1995
-----------------------------	-------------------------	----------------------------

1995 MAXIMA EXHAUST HEAT SHIELD RATTLE NOISE

APPLIED VEHICLE(S): 1995 Maxima (A32)

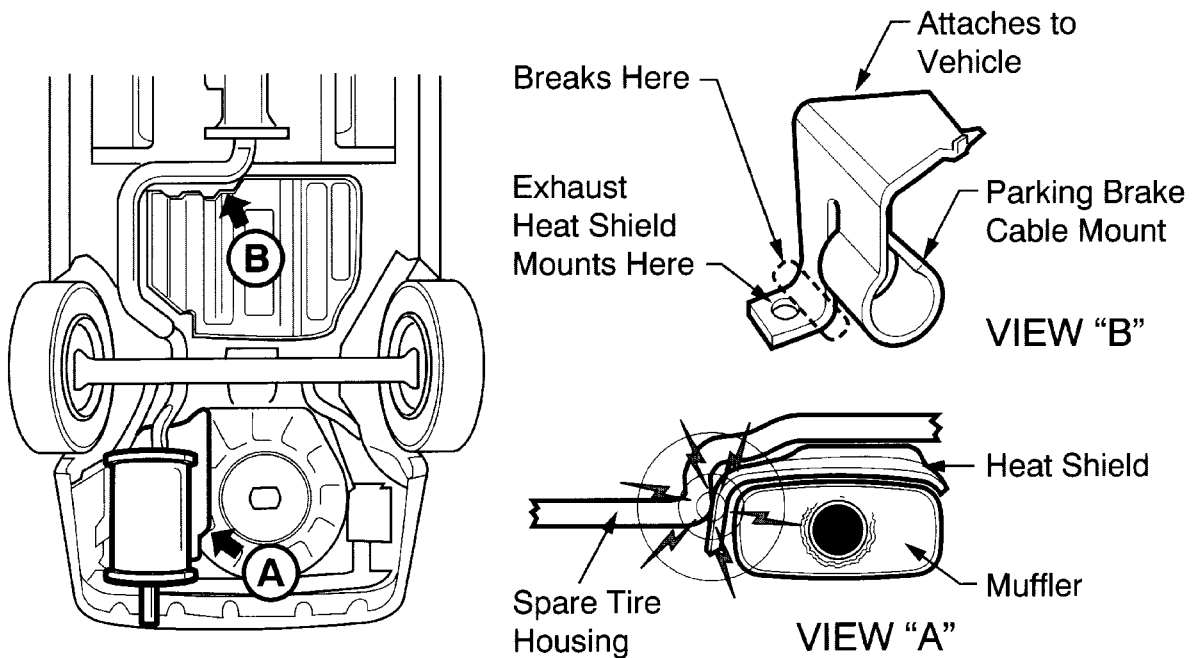
On some 1995 Maxima vehicles there may be a slight rattle noise from the rear of the vehicle when going over bumps. The exhaust heat shield may be contacting the spare tire well or the exhaust heat shield bracket may be broken (Figure 1).

1. Drive the incident vehicle to confirm the rattle noise.
2. Examine the forward exhaust heat shield bracket. If the bracket is broken, replace it. (The bracket may break at the tab where the heat shield mounts.)
3. Bend the rear muffler heat shield to provide adequate clearance from the spare tire well (Figure 2).
4. Road test to confirm the rattle noise is gone.
