SERVICE BULLETIN

Classification: BT95-007	Reference: NTB95-083	Date: September 6, 1995
-----------------------------	-------------------------	----------------------------

1995-1996 MAXIMA CENTER CONSOLE LID LATCH REPLACEMENT

APPLIED VEHICLE(S): 1995-1996 Maxima (A32)

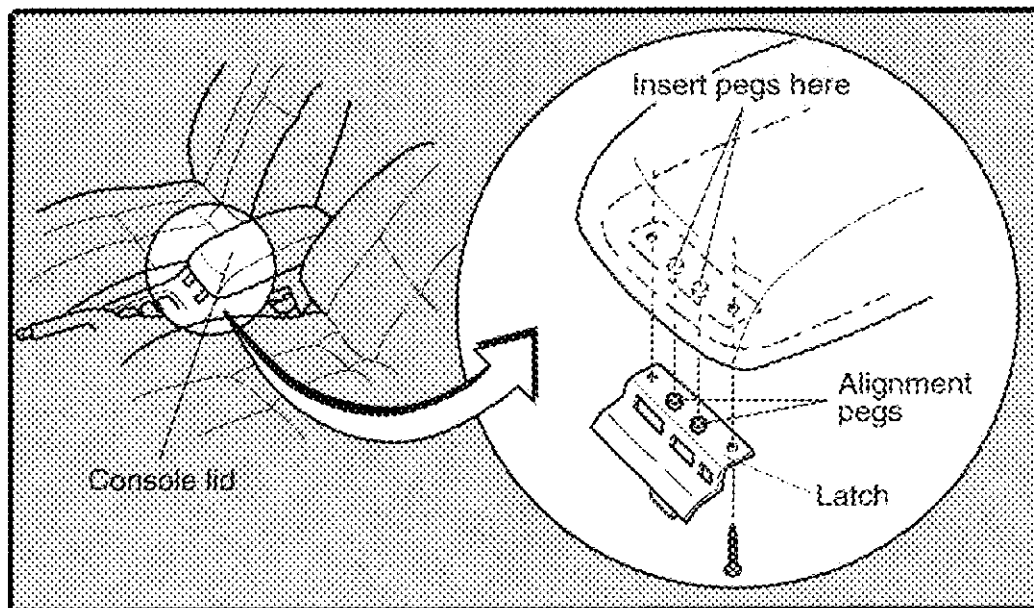
If a customer complains that the center console lid will not latch properly, this may be caused by a cracked or broken latch. An improved latch is now available separately, making replacement of the entire lid assembly for a broken latch no longer necessary. This new latch mounts to the console lid in the same manner as is currently used, and will fit any 1995-1996 Maxima.

1. Open console lid.
2. Remove the two latch mounting screws and detach broken latch.
3. Install new latch using the existing screws.

4. Check the alignment of the new latch by closing the console lid.
5. Align the lid by slightly loosening the hinge screws and adjusting as needed.
6. Verify the alignment is OK and tighten the screws at the hinge. The lid should open and close easily without binding.
