SERVICE BULLETIN

Classification: AT95-004	Reference: NTB95-095	Date: October 4, 1995
-----------------------------	-------------------------	--------------------------

1995-1996 MAXIMA A/T KEY INTERLOCK CABLE

APPLIED VEHICLE(S): 1995-1996 Maxima (A32)
APPLIED VIN(S): All equipped with automatic transmission

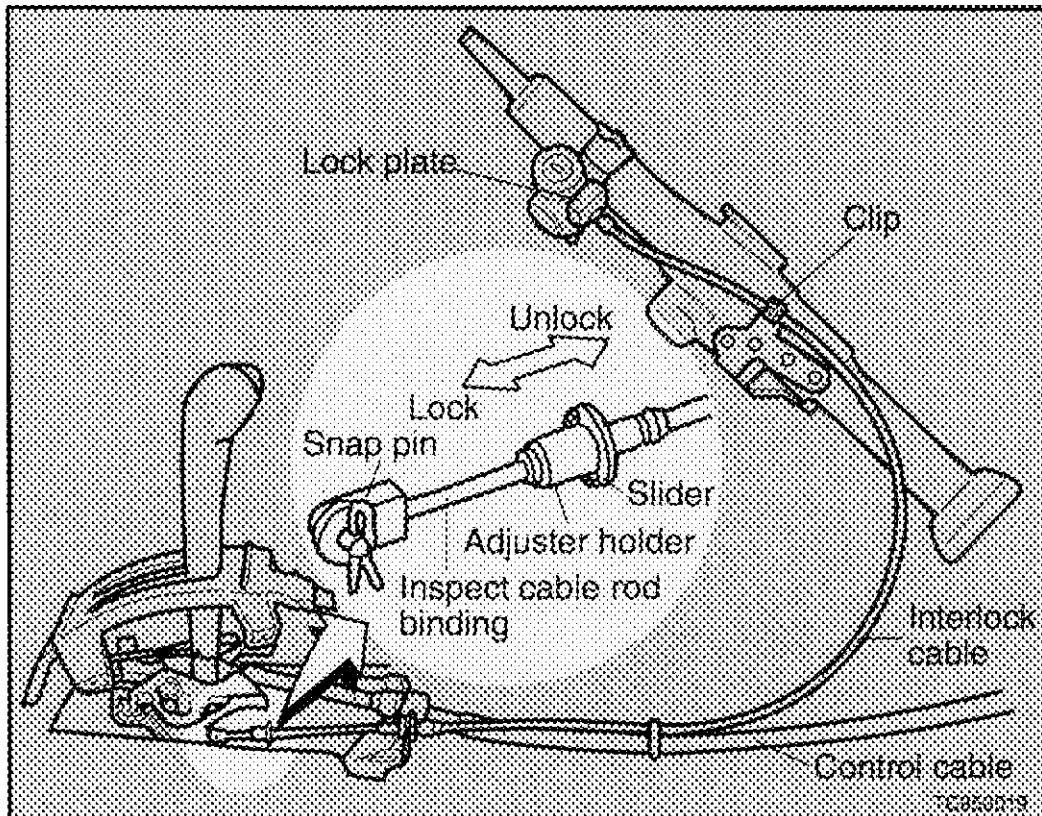
Customers may complain that the automatic transmission shift lever cannot be moved from Park under hot ambient conditions. The incident may occur more frequently when the vehicle is parked in direct sunlight. A new A/T interlock cable has been developed to reduce internal friction under hot ambient conditions.

1. After duplicating the incident, isolate whether the shifter or interlock cable is the cause of the incident. Disconnect the interlock cable from the shifter. If this does **not** resolve the incident, the problem is in the shifter. Refer to page BF-14 in the 1995 Service Manual or BT-13 of the 1996 Service Manual for additional service information.
2. Check for proper shifter solenoid operation, bent/broken parts, and evidence of spilled liquids (juice or soda). Repair/clean components as necessary and recheck operation.

3. If the incident is resolved in step 1, reconnect the interlock cable to the shifter and disconnect it from the ignition key. **If the incident returns**, the cable may be damaged and/or have excessive internal friction.
4. Replace the A/T key interlock cable with the part number listed in this bulletin. Refer to pages AT-122 in the 1995 Maxima Service Manual and A/T-121 & 122 in the 1996 Maxima Service Manual for proper cable removal, installation, and adjusting procedures.
5. Recheck interlock cable operation under the same ambient temperature conditions that the incident originally occurred.

Do not twist the adjuster holder when performing the cable adjustment. Twisting of the adjuster holder can increase internal friction of the cable and increase the risk of the shifter becoming stuck in park.

After cable replacement, ensure that the shifter **cannot** be moved after the key has been removed from the ignition. If the shifter can be moved without the key in the ignition, lengthen the cable adjustment and recheck.
