SERVICE BULLETIN

Classification: AT96-002	Reference: NTB96-007	Date: February 21, 1996
-----------------------------	-------------------------	----------------------------

RE4F04A AUTOMATIC TRANSMISSION (A/T) - DIFFERENTIAL PINION SHAFT WORN

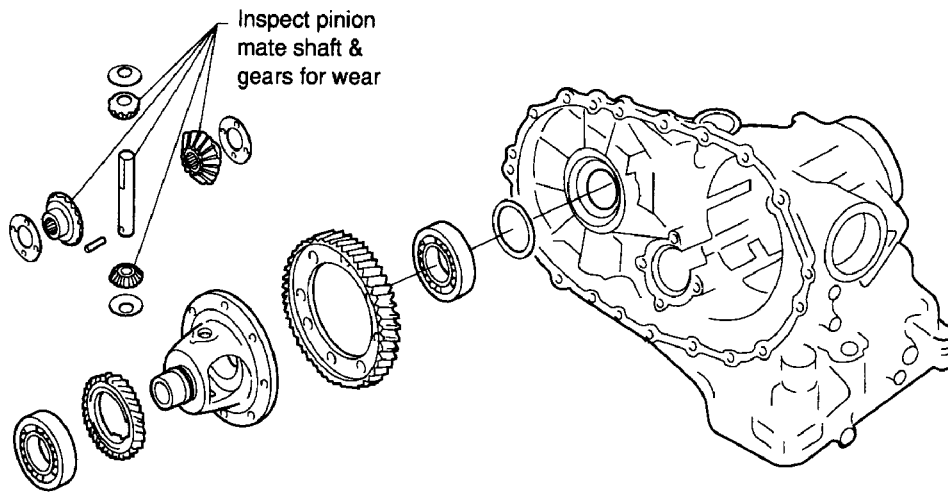
Debris from a worn differential pinion mate shaft can cause the following:

- Slipping on acceleration
- Hesitation and/or stalling when cold
- Abnormal noise coming from the transmission while driving

A countermeasure transmission differential case, with improved lubrication to the differential pinion mate shaft, has been developed to resolve these types of transmission incidents.

1. Verify the customer's complaint. If the transmission exhibits slipping on acceleration, hesitation and/or stalling when cold, or any abnormal noises coming from the transmission while driving, and no trouble codes are found in self-diagnosis, remove the transmission oil pan and inspect for metal debris.
2. If excessive metal debris is found, disassemble the transmission and inspect for burnt or worn components. If wear marks are found on the differential pinion mate shaft, (refer to Figure 1 on the following page), replace the shaft and install a countermeasure differential case P/N 38411-81X01. Replace all other burnt or worn components as necessary.
