SERVICE BULLETIN

Classification: AT96-003b	Reference: NTB96-009b	Date: June 5, 1996
------------------------------	--------------------------	-----------------------

RE4F04A AUTOMATIC TRANSMISSION (A/T) - WILL NOT SHIFT WHEN PLACED IN REVERSE

APPLIED VEHICLE(S):
1993-1996 Quest (V40)
1992-1994 Maxima SE (J30)
1995-1996 Maxima (A32)
1993-1996 Altima (U13)

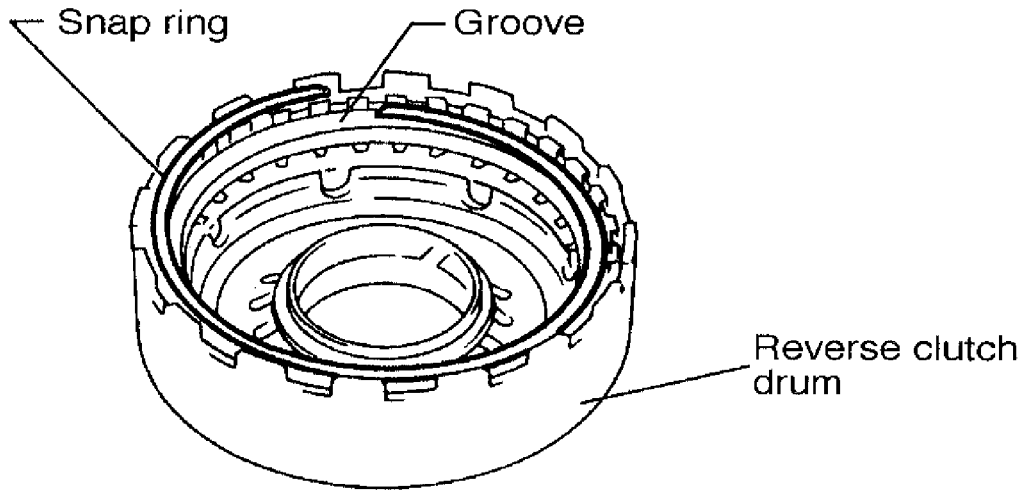
Figure 1

The reverse clutch drum snap ring may pop out of the inner drum retaining groove to cause this incident. A countermeasure reverse clutch drum, snap ring, and 2 dish plates has been developed to resolve this incident.

3. Perform a line pressure test using Kent-Moore J34301-C A/T pressure gauges. If the snap ring has popped out (refer to Figure 1), the line pressure in reverse will be low or zero.

4. If the line pressure is low or zero, remove the reverse clutch drum and inspect the snap ring and retaining groove. If the snap ring has popped out, replace the snap ring using the part number on the following page. If the reverse clutch inner drum retaining groove shows signs of wear, replace the reverse clutch drum using the part numbers listed on the following page.
