SERVICE BULLETIN

| Classification: AT96-010 | Reference: NTB96-110 | Date: December 23, 1996 |

RE4F04A AND RE4F04V AUTOMATIC TRANSMISSION (A/T) - SOLENOID VALVE REPLACEMENT PROCEDURES

APPLIED VEHICLE(S): 1992-94 Maxima (J30)
1995-97 Maxima (A32)
1993-97 Quest (V40)
1993-97 Altima (U13)

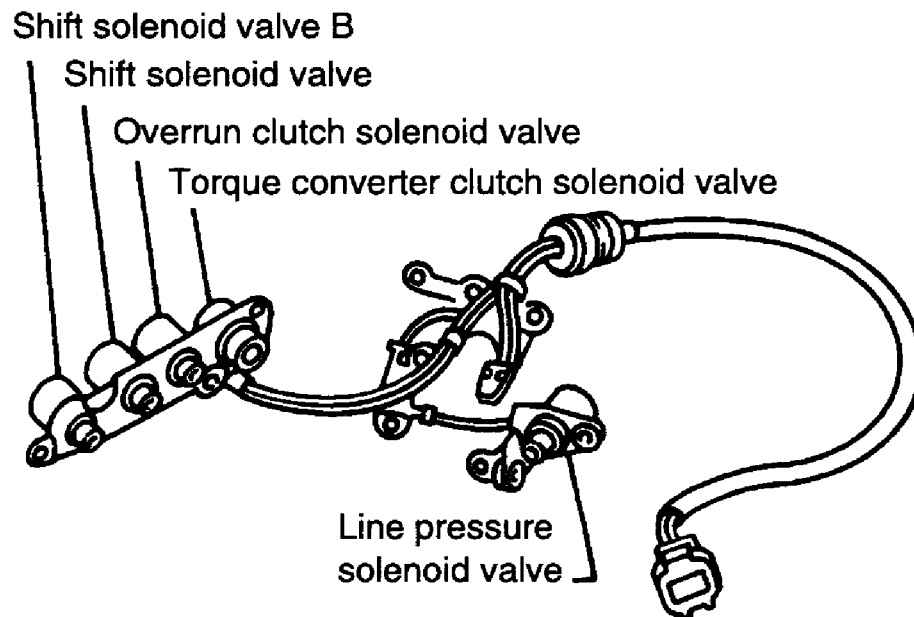
Figure 1

The RE4F04A and RE4F04V A/T are equipped with five solenoid valves as shown in Figure 1. Perform the Service Procedure beginning on page 2 whenever the solenoid valve assembly is replaced.

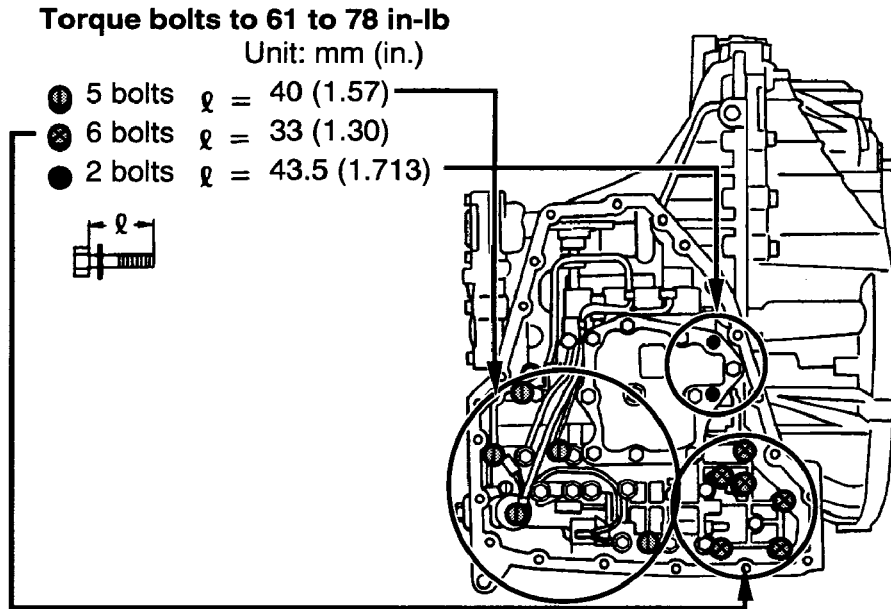
Figure 2

CAUTION: The control valve assembly **must be removed prior** to removing the solenoid valve assembly. If the solenoid valve assembly is replaced without removing the control valve assembly the transmission will develop unusual shifting.

1. Remove the thirteen, 10 mm bolts holding the control valve assembly to the transmission. Remove the control valve assembly (Figure 2).

5. Reinstall the control valve assembly and torque the thirteen retaining bolts to **61-78 in-lb**. Note the different bolt lengths and locations shown in Figure 2.

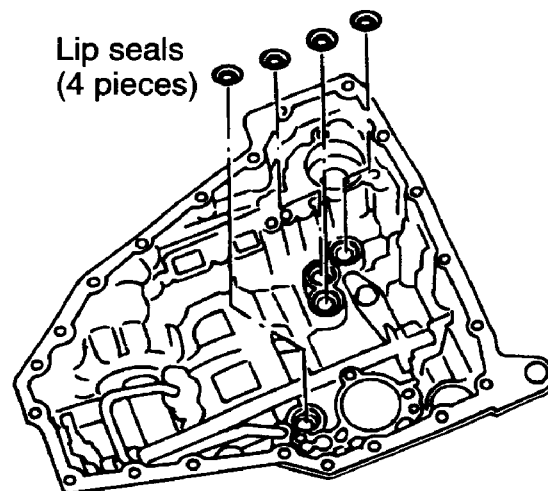
Figure 3

CAUTION: The four O-rings (lip seals) behind the solenoid valve assembly must be reinstalled to their original locations. Out-of-position or cut lip seals will cause unusual shifting incidents.

2. Remove the two solenoid valve assembly retaining bolts and remove the solenoid valve assembly.
3. Install the new solenoid valve assembly into the control valve assembly.
