SERVICE BULLETIN

Classification: BT97-008a	Reference: NTB97-046a	Date: November 1, 1997
------------------------------	--------------------------	---------------------------

1995-97 MAXIMA POWER SEAT LIFT MOTOR OUTPUT GEAR STRIPPED

APPLIED VEHICLE: 1995 through early 1997 Maxima (A32)
APPLIED VIN(S): Vehicles built before JN1CA21D*VT807898,
JN1CA21D*VT202921 and JN1CA21D*VM501784
APPLIED DATE: Vehicles built before August 3, 1996

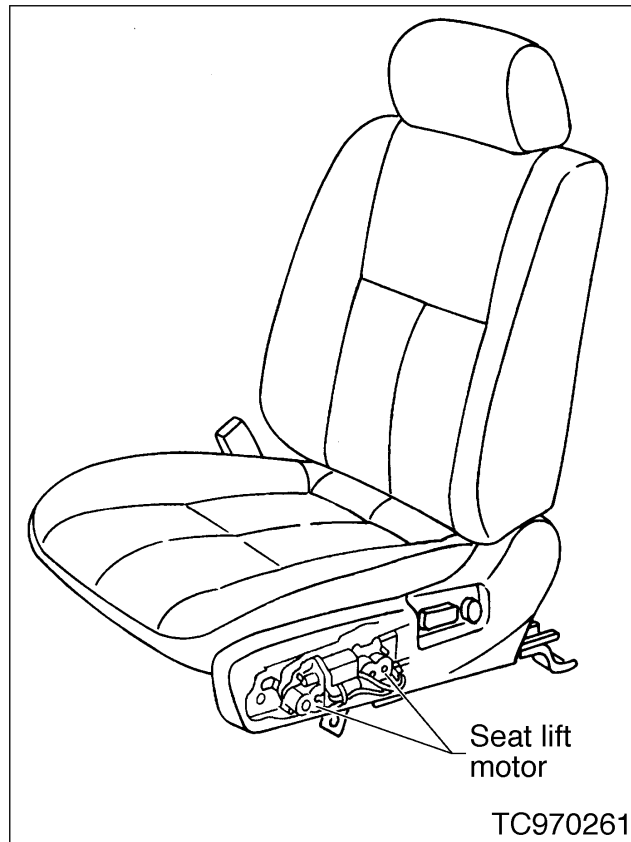
Figure 1

If the power seat lift adjustment on a 1995, 1996 or early 1997 Maxima is not working, the plastic output gear of the lift motor may be stripped.

1. To verify this condition, operate the lift switch while sitting in the seat.
2. Listen for the motor operation and watch the seat for a change in height.
3. If there is no seat movement, remove the motor from the seat frame and inspect the plastic gear (see Figure 1, page 2).
4. If the plastic gear is stripped, use the procedures in the BT section of the service manual to replace the adjuster assembly and finisher assembly with the countermeasure parts.

Individual countermeasure parts are not interchangeable - replace them as a set only.
