# SERVICE BULLETIN

Classification: BT97-031	Reference: NTB97-099	Date: February 1, 1998
-----------------------------	-------------------------	---------------------------

## 1995-98 MAXIMA SUNROOF WATER LEAKS DUE TO REAR DRAIN TRAY GUIDE

**APPLIED VEHICLE:** All 1995-98 Maxima (A32)

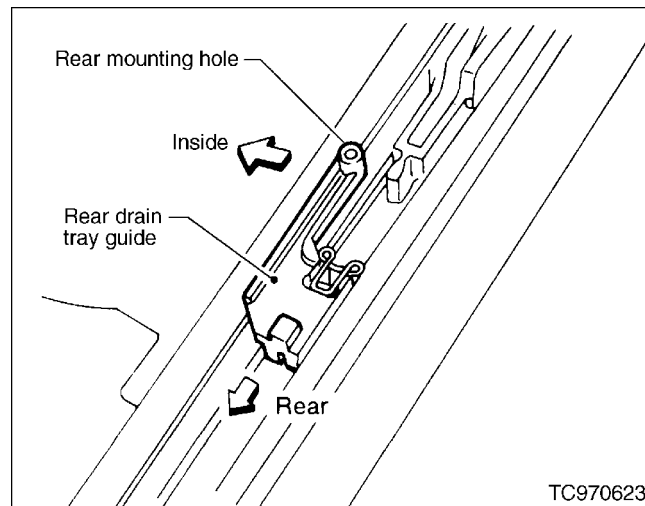
Figure 1

If a 1995-98 Maxima exhibits sunroof water leaks, the cause may be an improperly positioned sunroof rear drain tray that may be from broken drain tray guide(s).

Replace drain tray guide(s) according to service procedures outlined in the appropriate service manual:

- For 1995 Maxima, see pages BF-33 through BF-35 of the 1995 Maxima Service Manual.
- For 1996 Maxima, see pages BT-28 through BT-30 of the 1996 Maxima Service Manual.
- For 1997 Maxima, see pages BT-32 through BT-34 of the 1997 Maxima Service Manual.
- For 1998 Maxima, see pages BT-34 through BT-36 of the 1998 Maxima Service Manual.
