SERVICE BULLETIN

Classification: BT98-023	Reference: NTB98-076	Date: September 15, 1998
-----------------------------	-------------------------	-----------------------------

1995-98 MAXIMA CONSOLE LID REPAIR

APPLIED VEHICLE: 1995-98 Maxima (A32)
APPLIED VINS: Vehicles built before: JN1CA21A2WT309248
JN1CA21AXXT700102
JN1CA21DXWT536147
JN1CA21D0XT800204
JN1CA21D*WM932169
JN1CA21D*WM807735
APPLIED DATE: Vehicles built before May 13, 1998

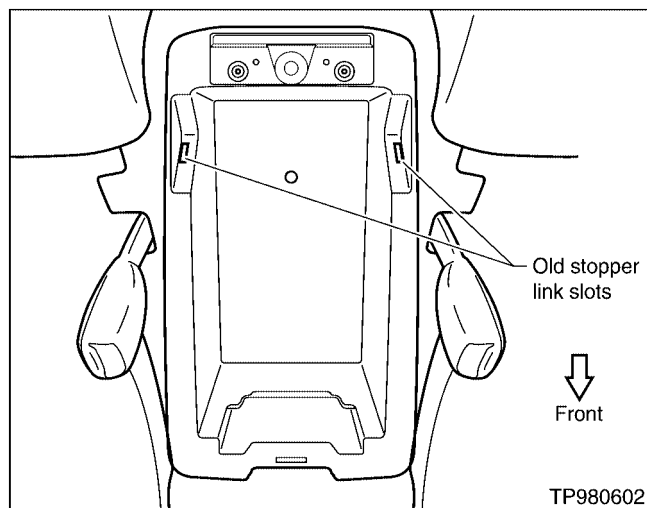
Figure 1

If the console lid on an applied 1995-98 Maxima disconnects from the console box, wiggles or seems loose when opened, excessive lid opening force may have caused one or both of the console lid stopper links to disconnect from, fall out of, or become bent in the slots in the console box.

1. Open the console lid and remove any items inside the console box.
2. Unscrew the console lid hinge from the console box. Slide any remaining lid stopper links out of their slots and remove the console lid (see Figure 1).
