SERVICE BULLETIN

Classification: BT98-025	Reference: NTB98-080	Date: October 1, 1998
-----------------------------	-------------------------	--------------------------

1995-98 MAXIMA POWER SEAT CABLE

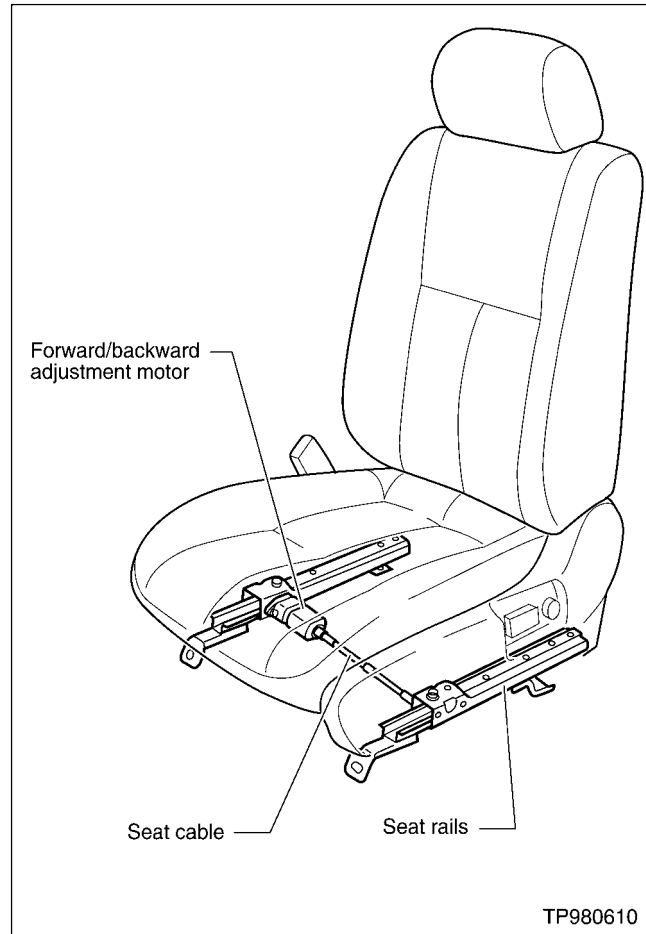
Figure 1

If the front driver's or passenger's power seat on an applied 1995-98 Maxima does not move forward or backward when operating the switch and all other power seat functions are performing correctly, the inner rotating wire of the power seat drive cable may be broken. This condition may also result in a grinding or grating noise heard when operating the switch.

3. Confirm the electrical connectors are attached to the motor and that power is available to the motor (see Figure 1).

4. Verify both ends of the seat cable are fully seated.
5. If the forward/backward seat adjustment is still not operating, replace the seat cable with the new part.

6. After installation, make sure the cable-end connectors are secure. Verify the seat moves forward and backward smoothly.
