SERVICE BULLETIN

Classification: BT98-031	Reference: NTB98-100	Date: December 1, 1998
-----------------------------	-------------------------	---------------------------

1998 MAXIMA LEFT REAR DOOR DOESN'T UNLOCK WITH REMOTE

APPLIED VEHICLE: 1998 Maxima (A32)
APPLIED DATE: Vehicles built before May 6, 1998

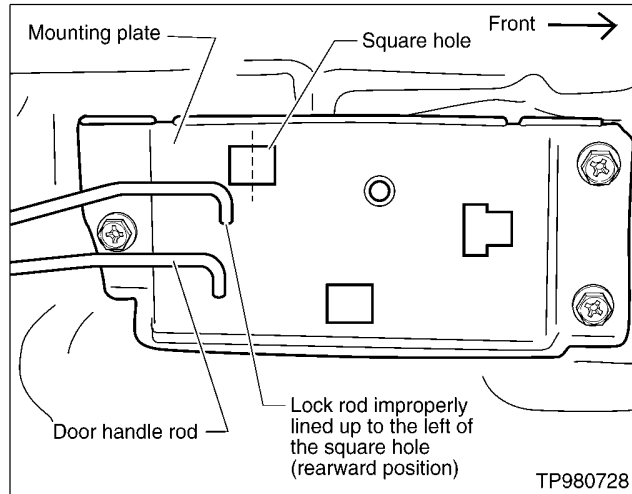
Figure 1

If the left rear door on an applied 1998 Maxima does not always unlock when using the remote or the main switch on the driver's armrest, the door lock control rod may be improperly installed and/or too short.

If it is too short, the stroke or travel of the lock rod might be reduced. The result may be that the lock button only moves half way. In some cases, the actuator may also make an abnormal noise.

5. Move the lock rod to the rearward position.
6. Look at the position of the lock rod in relation to the square hole in the door handle mounting plate. An improperly positioned lock rod will be too short and will line up to the left of center of the square hole when the lock rod is moved into the rearward position (see Figure 1).
