SERVICE BULLETIN

Classification: AT99-001a	Reference: NTB99-014a	Date: June 19, 2000
------------------------------	--------------------------	------------------------

1998-1999 MAXIMA AT SHIFT CONTROL DEVICE - HARD TO SHIFT

APPLIED VEHICLE(S): 1998-99 Maxima (A32)

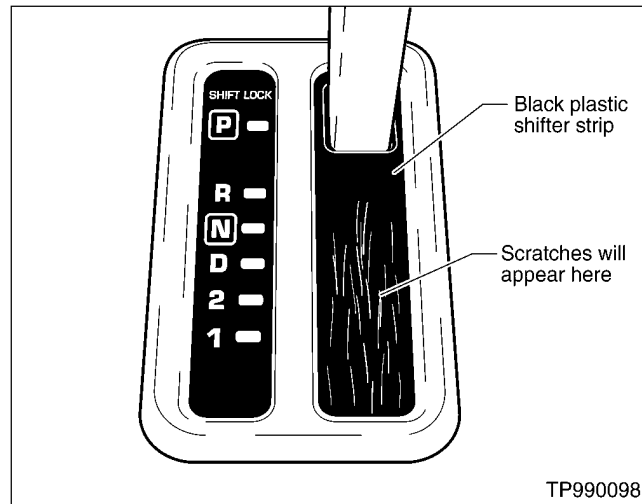
Figure 1

This incident may be difficult to duplicate unless the vehicle is heat soaked. Scratch markings may also be observed running the length of the sliding black plastic shifter strip (see Figure 1). (This plastic strip slides within the slot as the shift handle is moved.)

The root cause of this incident is insufficient clearance between the indicator assembly and the base of the shift control device. This lack of clearance causes the sliding black plastic strip to bind, which increases operating effort. Two service procedures are provided to correct this incident.

For cases where the shift effort is high and the sliding black plastic strip has scratches as shown in Figure 1, replace the strip with PN 96955-2L900 **and** add the plate adapter (PN 34981-79900) as follows:
