# SERVICE BULLETIN

Classification: BT99-005	Reference: NTB99-024	Date: April 15, 1999
-----------------------------	-------------------------	-------------------------

## 1995-99 MAXIMA WIND NOISE REPAIR

**APPLIED VEHICLES:** 1995-99 Maxima (A32)

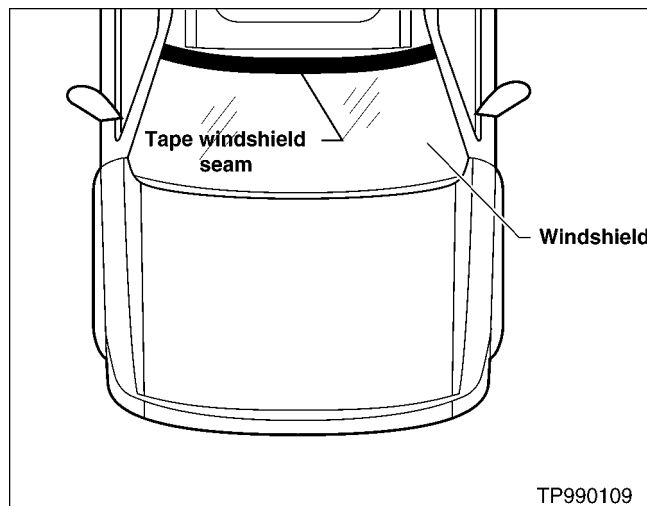
Figure 1. Windshield

#### Incident 1: Wind noise "hiss" or "fluttering" along upper edge of the windshield.

To identify where an air leak exists, insert a business card or feeler gauge between the windshield and the upper molding. Slide the card along the molding to find a loose spot, indicating a potential leak.

2. Clean the windshield edges.
3. Apply a suitable glass sealant (3M Black Silicon Sealant P/N 051135-08662 or equivalent) to the upper edge of the windshield.
4. Re-install the moldings.
5. Wipe off excess windshield sealant.

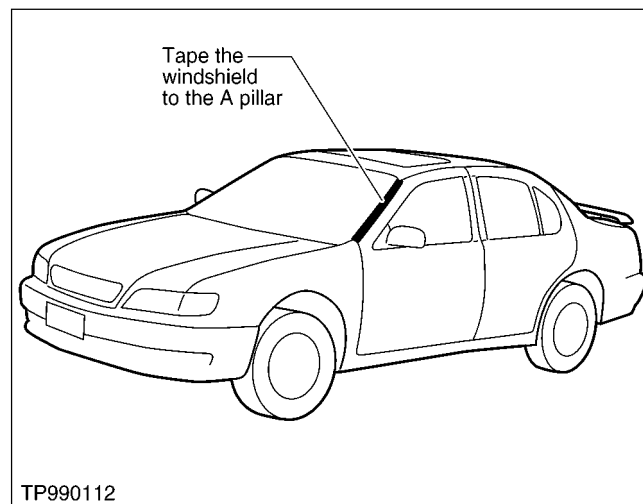
Figure 2. Windshield side molding

**Incident 2: Wind noise, 'hiss' or 'fluttering', along the A pillar.****Verify:**

The cause of the wind noise is the windshield side moldings.

1. Remove both windshield side moldings.

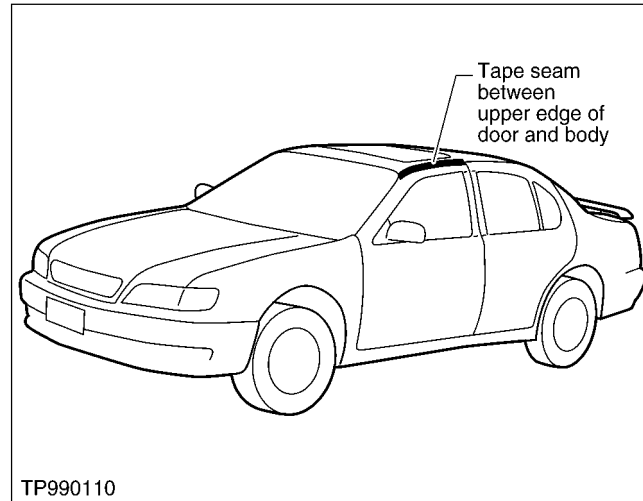
Figure 4. Upper Edge of Door

**Incident 3: Wind noise "hiss" along front door roofline between A & B pillars.****Verify:**

1. Close the door. From the outside, insert a business card or feeler gauge down between the door and the weather strip. Slide the card along the weather strip. A loose spot indicates a potential leak.
2. Open the door. Spray the top edge of the door contact with powder spray (Crest Leak-Trace, Stock No. AT-R, or equivalent. Dealers should call 1(800) 822-4100 to find their local Crest distributor. Carefully close the door, pushing at the striker until the second latch has closed (try not to push the door past the second latch closing, this may mask the leak detection process). Re-open the door. An un-smear spot will indicate a potential leak.

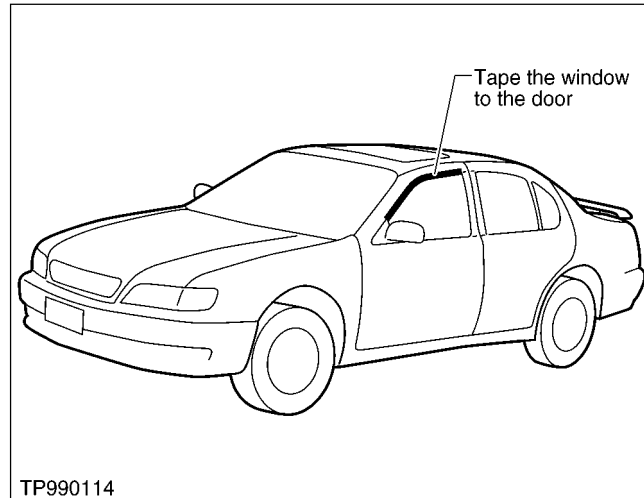
Figure 6. Upper Edge of Door

**Incident 4: Wind noise "hiss" along the top edge of the front door glass.**

1. Roll the window up completely. From the outside, insert a business card or feeler gauge between the window and the run rubber. Slide the card along the run rubber to find a loose spot, indicating a potential leak. Repeat on the inside of the door.
2. Roll the window half-way down. Spray the top outside and inside edges of the window with powder spray (Crest Leak-Trace, Stock No. AT-R or equivalent). Roll the window up completely and then back down. An un-smeared spot will indicate a potential leak.

1. Remove the run rubber from the door frame.

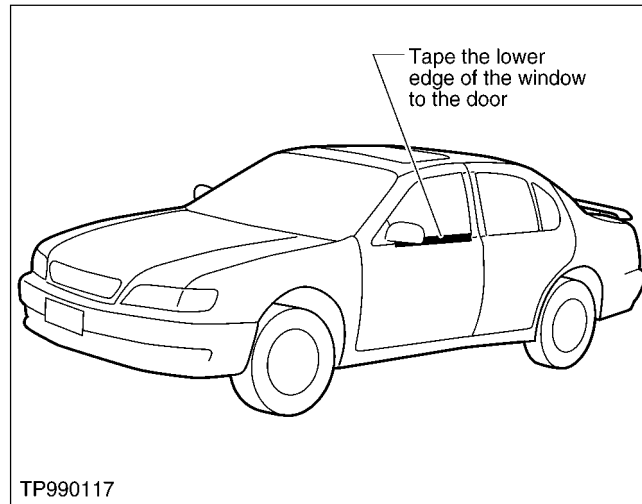
Figure 8. Lower Edge of Window

**Incident 5: Wind noise "hiss" from the window along waist or "belt" line of the front door.**

- 1. Roll the window up completely. Insert a business card or feeler gauge down between the window and the lower molding. Slide the card along the molding to find a loose spot, indicating a potential leak. Repeat on the inside of the door.
- 2. Roll the window up completely. Spray the lower edge of the window with powder spray (Crest Leak-Trace, Stock No. AT-R or equivalent). Roll the window down and then back up. An un-smearred spot will indicate a potential leak.

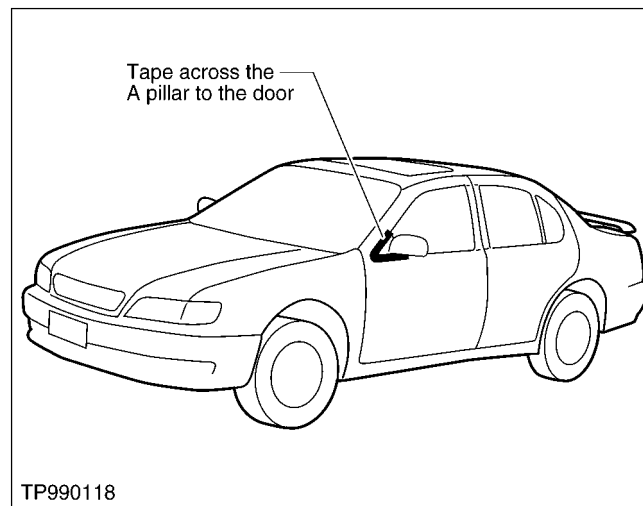
Figure 11. Lower Edge of Window

**Incident 6: Wind noise 'hiss' from the side mirror, noticed at the inner finisher near the forward edge of the waist molding.**

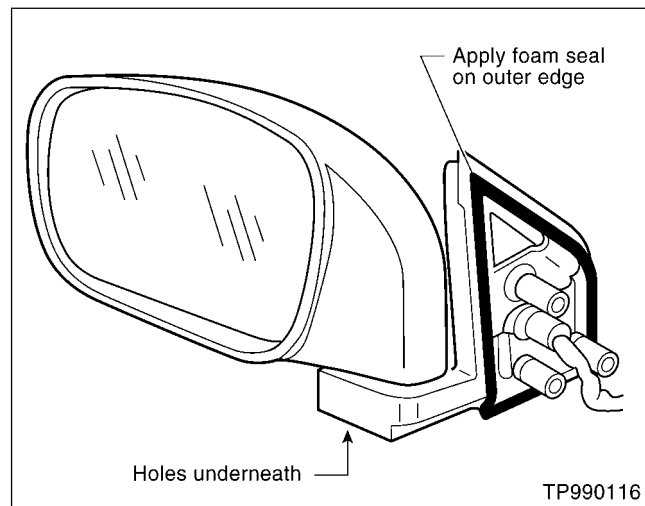
Figure 12. Side Mirror

**Incident 7: Wind noise that appears to be coming from the side mirror or may be noticed along side window.****Verify:**

1. Remove the side mirror.
2. Cut a piece of foam seal (3M Scotchfoam P/N 051131-06375 Tape No. 4508 or equivalent ) 7 mm wide (approximately one-quarter inch wide). Attach this strip all the way around the edges of the mirror (see Figure 12).

3. Re-install the mirror, making sure to tighten sufficiently. This should eliminate any gap that existed between the mirror and the body.

Fill the holes with a suitable glass sealant (3M Clear Auto Sealer P/N 051135-08551 or equivalent). Wipe off any excess sealant.
