SERVICE BULLETIN

Classification: EM94-007	Reference: NTB94-089	Date: September 13, 1994
-----------------------------	-------------------------	-----------------------------

VG30 ENGINE OIL DIPSTICK CAUTION

APPLIED VEHICLE(S): All VG30i/E or VG30DE equipped models

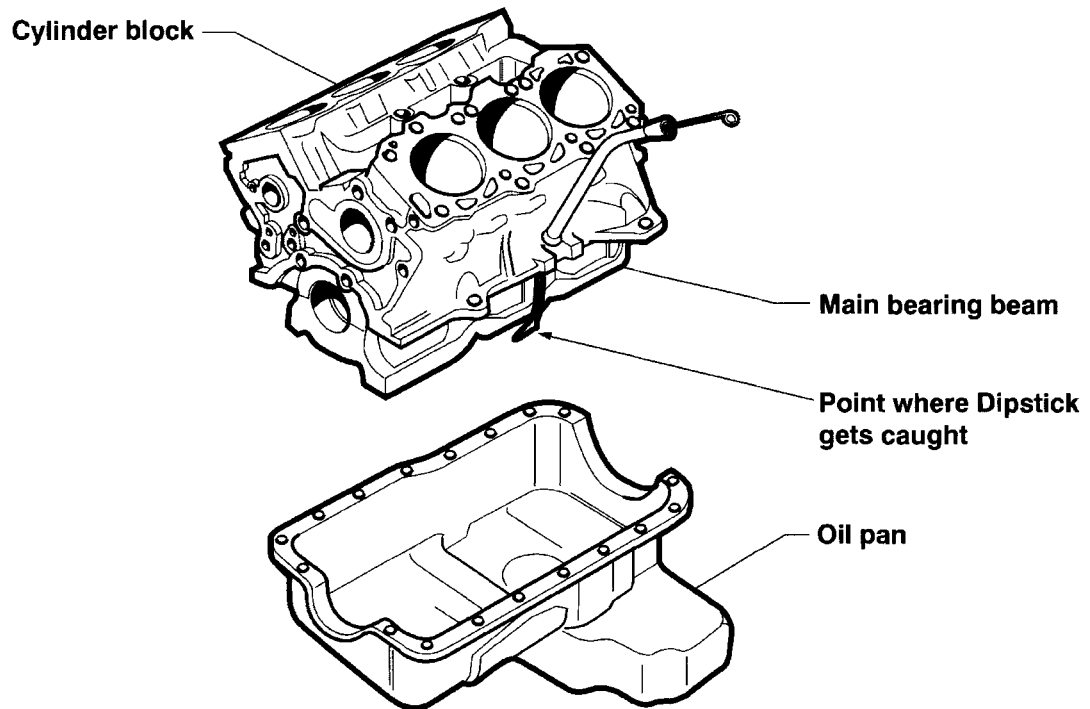
When performing any service that requires removal of the oil pan, always remove the dipstick before replacing the oil pan. If the dipstick is left in the engine the end of it may become caught between the main bearing beam and the windage tray of the oil pan. The only way to remove the dipstick after it has been caught is to remove the oil pan.
