SERVICE BULLETIN

Classification: BT95-012	Reference: NTB95-008	Date: January 25, 1995
-----------------------------	-------------------------	---------------------------

1995 MAXIMA SPARE TIRE COVER RATTLE NOISE

APPLIED VEHICLE(S): 1995 Maxima (A32)

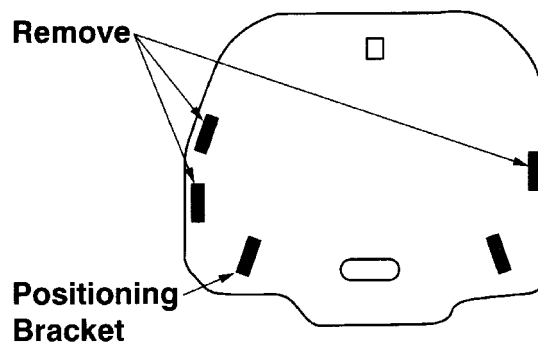
Figure 1

1. Remove the three (3) pieces of the foam tape originally installed on the bottom of the spare tire cover (figure 1).

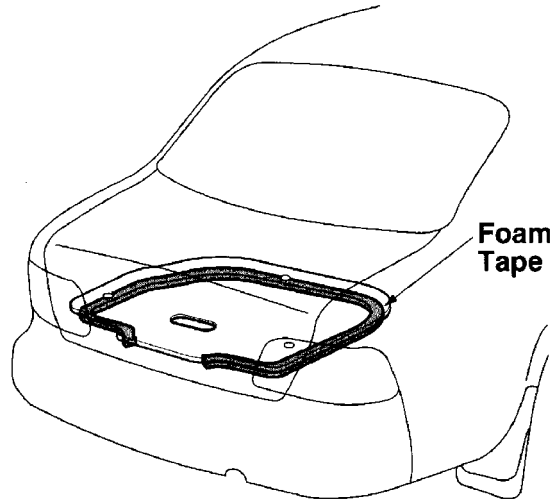
Figure 2

2. Install foam tape around all edges of the spare tire cover except the edge below the handle opening (figure 2).

Foam tape to be used is 3M SCOTCHFOAM Black Vinyl Foam Tape. Tape can be purchased from 3M as part number 06370, tape No. 4504 Size: 3/4 in. Contact your local 3M representative or call 1(800) 521-8180 extension 6890 for the number of the nearest distributor.
